ANALYSIS OF THE FEASIBILITY OF REPLACING FABRIC SKIN IN HALF-SHELL STRUCTURAL DESIGNS

Abstract: One of the many issues associated with aircraft operations is that of structural designs with fabric skin. As one of the solutions addressing these problems, this paper proposes replacing the existing fabric skin with a new covering made of a composite material. The object of analysis available to the authors was a horizontal stabilizer of Mi-2 helicopter. This paper presents the results of fatigue tests applied to the thin-walled structure of the horizontal stabilizer, carried out under two scenarios: (I) with the fabric skin removed and (II) with the composite material skin installed. During the tests, strain values were measured at selected points of the stabilizer structure, using linear type resistance strain gauges and in a rectangular rosette arrangement. The test results confirmed the feasibility of replacing the fabric skin with a composite material skin.

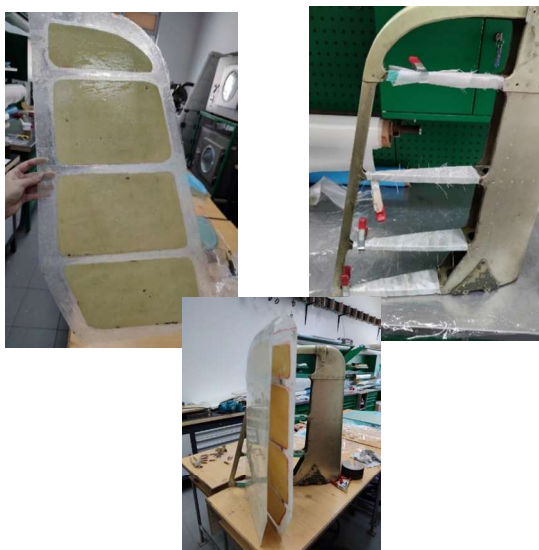
Fig. 2. The top plate of the stabilizer cover and the interior of the new stabilizer cover [Photo S. Tkaczuk]

The composite material skin (Fig. 2) was made as a single component consisting of an upper and lower

covering plate and a runoff element connecting the two plates into a single unit. Each cover plate consists of two layers of E91 glass fabric infused with resin, with Herex foam sandwiched between them - resulting in a sandwich design [3]. The application of foam was intended to make the cover plates rigid in the rib spacing. The base in the composite material was LR285 epoxy resin + H285 hardener [6].

The covering element prepared in this way was glued to the stabilizer skeleton. The component was glued directly to the caisson plate and racks of rib No. 1 and the trailing edge, while for the other ribs, i.e., No. 2, No. 3, and No. 4, were glued through the composite cladding with which they were previously covered. In addition, along the edge of the caisson at the height of each rib, the composite element was riveted with one-sided rivets

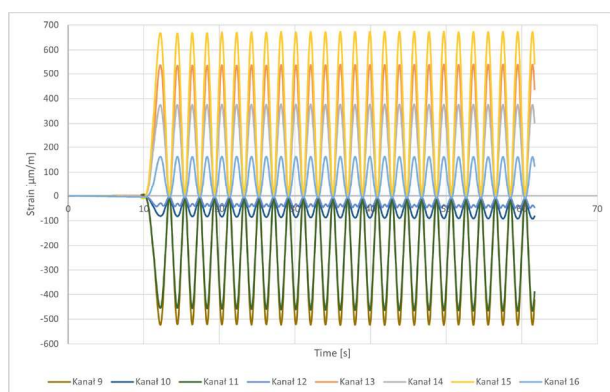
Fig. 6. Graph of strain changes over time for the initial 0 cycles - before fatigue testing: Channels 9-12 - strain gauges on the top surface of the stabilizer, Channels 13-16 - strain gauges on the bottom surface of the stabilizer

for the number of cycles 0 and 500,000 are shown in Figures 6 and 7.

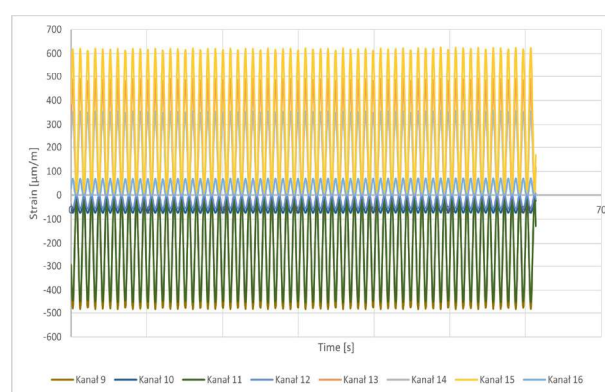
Fig. 7. Graph of strain changes over time for the final 500,000 cycles - after the end of the fatigue test: Channels 9-12 - strain gauges on the top surface of the stabilizer, Channels 13-16 - strain gauges on the bottom surface of the stabilizer

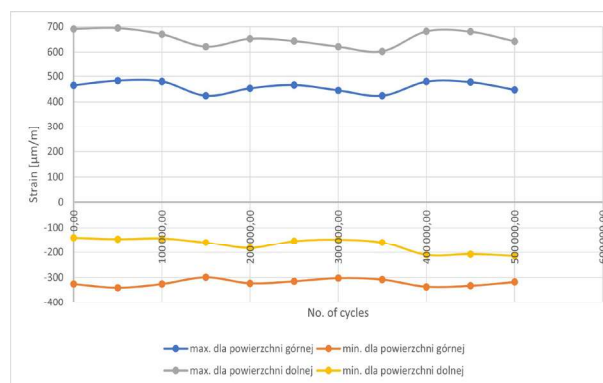
Fig. 8. Values of maximum and minimum major strains

The results collected in Table 4 are presented graphically in the summary Figure 8. The figure shows the maximum and minimum values of the calculated major strains. The values of maximum major strains were recorded on the skin of the bottom surface of the stabilizer in tension, whereas the values of minimum major strains were recorded on the skin of the top surface of the stabilizer in compression.
