STRENGTH TESTS OF REPAIR JOINTS LOADED WITH TENSION AND LOSS OF STABILITY

Iga BARCA^{1,*}

During aircraft service, the skin is the component that first comes into contact with factors that can cause mechanical damage - that is why it is most often damaged during use. Semi-monocoque aircraft structures are made of a skin and a frame. The skin is an element that significantly affects the safety of the structure, since it transfers loads between the elements of the frame. For this reason, the skin is subject to special supervision during technical maintenance, and any damage detected must be repaired. The research was carried out on specimens made of AW 2024-T3 plate sheet with a thickness of 1 mm. In the study, a comparative analysis of damaged, undamaged and repaired specimens loaded in tension and compression was performed. Different patches were used in repaired specimens, made of metallic as well as composite materials, connected to the structure with rivets or using adhesive materials. The study showed that the use of riveted as well as adhesively bonded overlays does not allow the original strength of the tensile-loaded skin to be restored, but does allow the strength of the

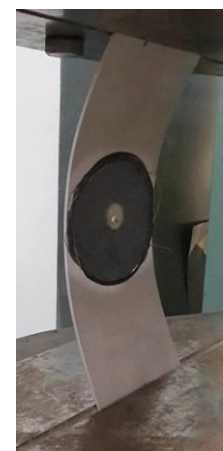
Fig. 5. Specimen loaded with compressive force

The manner of deformation of the specimens during the compression test is shown in Figure 5. The results of the static compression tests carried out on the specimens with repair nodes. Again, three specimens were tested for each case, and the resulting force values were averaged and placed in a Table 3.

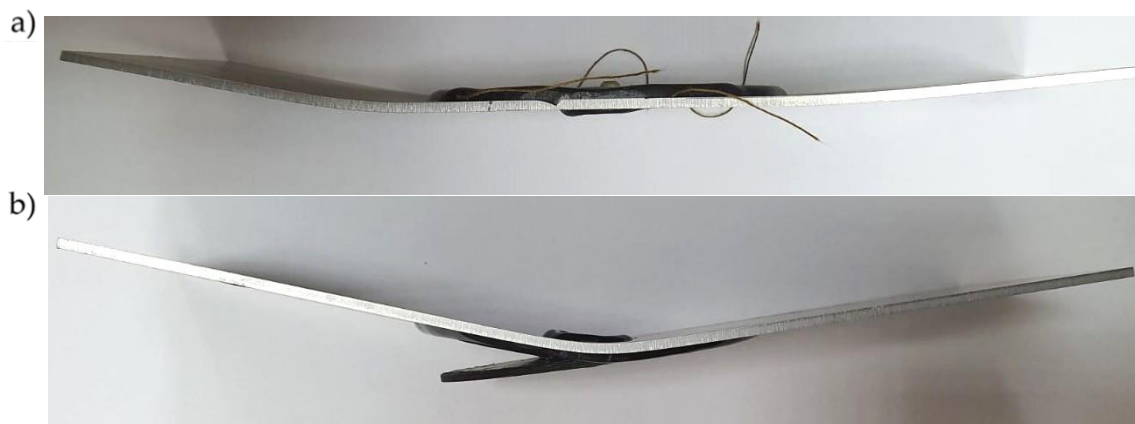
Fig. 6. Failure mode of specimens with CFRP patch: a) permanent deformation outside the repair node, b) failure of the adhesive joint

The critical force for the specimen with the hole was about 7% less than the critical force of the undamaged specimen. Each of the repair methods used resulted an increase in the critical force of the repaired specimens compared to the critical force of the undamaged specimen. In specimens with a CFRP patch bonded with DP 420 adhesive (Figure 6a), plastic deformation of the specimen material outside the repair node occurred during loading - what meant that the repair node excessively stiffened the specimen in the repair zone. Plate deformation in plastic range outside the patch. In the case of large deformations of the loaded specimen, failure of the adhesive bond also occurred, but only when the repair patch was on the tensile side during bending of the specimen. (Figure 6b, Figure 7).

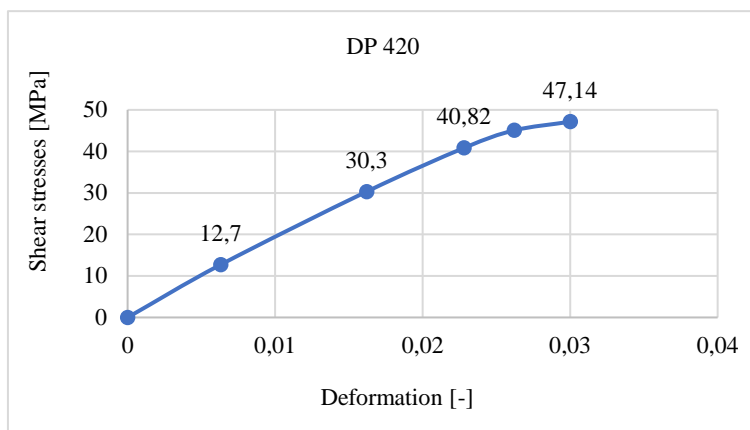
Fig. 8. $\sigma = (\sigma)\epsilon$ curve of DP 420 adhesive

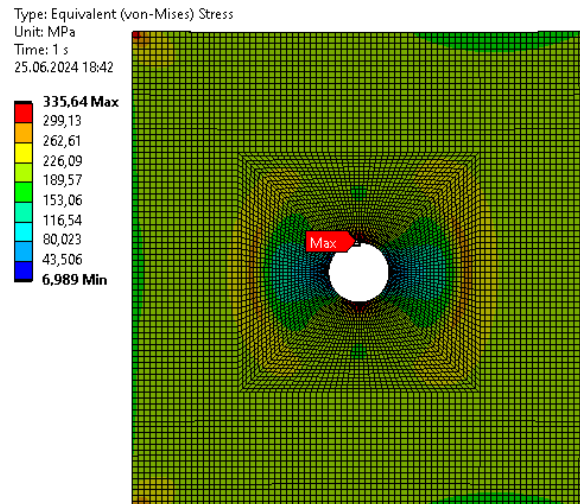
Fig. 15. Von-Mises stress map (Case IV)

Example maps of reduced stresses according to the Huber-M-H hypothesis in plates for the four design cases are presented in Figures 12, 13, 14, 15, while

The results of the numerical analysis show that the geometry of the model has an impact on the values of reduced stresses in both the adhesive joint and the patch. Significant differences in stress values are found in the composite patch (44%) and the adhesive joint (35%). Regardless of the analyzed changes in the geometry of the plate model, the maximum values of reduced stresses (according to the Huber -M-H hypothesis) in the repaired model are very close to each other (differences at the 1% level).
