## ANALYSIS OF THE AIRFRAME REPAIR NODE

### ANALIZA WĘZŁA NAPRAWCZEGO POKRYCIA PŁATOWCA

Polymer composite materials can be used both for the production of semi-monocoque structures and for the repair of aircraft airframes. Of all the elements of the semi-monocoque structure, the airframe skin is most often damaged during operation. The fragments of the skin between the frame elements of the semi-monocoque structure are considered as a thin-walled plate. The paper presents an analysis of the repair node of a metal plate subjected to uniform shear. The model of the repaired plate made in the Ansys Workbench environment was used for the analysis. The boundary conditions were defined by means of an articulated frame using the possibilities of the computing environment in the scope of, defining elements among others. The model was initially verified experimentally, assuming that it can be used to carry out a comparative analysis of two methods of repairing a damaged plate, using CFRP (Carbon Fiber Reinforced Polymer) and GFRP (Glass Fiber Reinforced Polymer) materials. Analyzing the obtained results, it was found that the repair does not restore the original strength of the damaged st

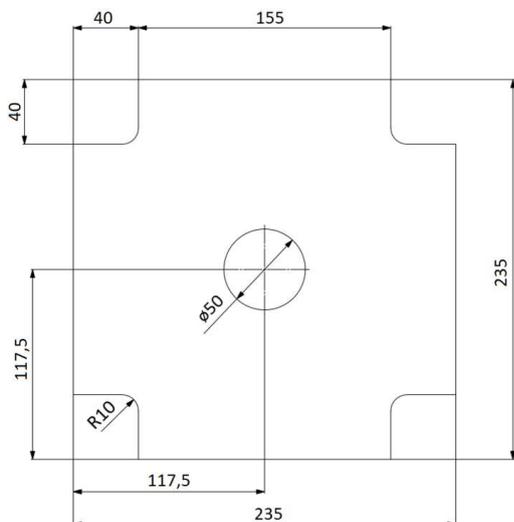
Fig. 1. Dimensions and shape of the plate used in the test

In order to perform numerical calculations, a simplified model of the plate with a loading frame was prepared in the NX 11 environment. As part of the model being performed, the plate, repair elements, articulated joints and a frame for mapping the plate shear were defined. The following assumptions were adopted to define the plate model: thickness 1 mm and material properties of the 2024-T3 series aluminum alloy. The geometrical dimensions of the plate with a damage in the form of a hole with a diameter of 50 mm are presented in Fig. 1.

The specimen for experimental tests was made of 1 mm thick 2024-T3 sheet, aluminium alloy with the dimensions shown in Fig. 1. The repair of the plate consisted of installing a metal insert in a hole with a diameter of 50 mm. The composite patch was formed of 16 layers of SynglassE86 glass fabric with diameters from 127 mm to 142 mm, in 1 mm increments. The test surface was degreased with extraction naphtha and with the use of a 3M SC-DR disc of granularity P180 and P400. Only the area on which the patch was to be formed was processed. The surface preparation process was completed with another surface cleaning with extraction naphtha. The L285 epoxy resin mixed with the H285 hardener in the proportions 100: 40 was used as the saturant of the composite patch. The filtered material layers were layered according to the scheme  $[0^\circ, 30^\circ, 60^\circ, 90^\circ]_4$ . Then, next layers used in the vacuum bag technology, including a resin draining mat, perforated foil and delaminating fabric, were applied to the composite patch. The patch prepared in this way was placed in a device enabling to generate a pressure equivalent to a pressure of 0.8 MPa and left for 24 h at room temperature (according to the technical sheet for curing resin L285/H285). The prepared composite patch was adhesively bonded to

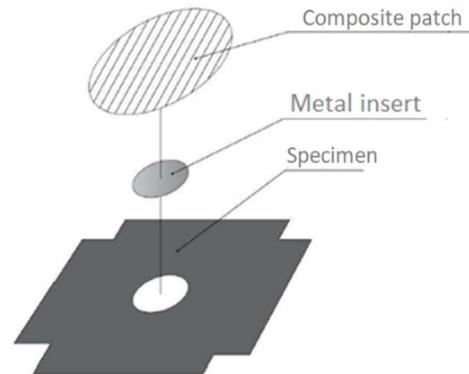
Fig. 2. Elements of the repair node

The model of the repaired plate consisted of elements that are used in the repair process. Inside the hole, a metal insert is defined, while on one of the outer surfaces of the plate a composite patch with the material properties of a glass (GFRP) and carbon (CFRP) composite was modeled. The properties of the glass composite corresponded to the material prepared on the basis of SynglassE86 glass fabric with a grammage of 101 g/m<sup>2</sup> and the L285/H285 (MGS) impregnated by Havel Composites (Fig. 2).

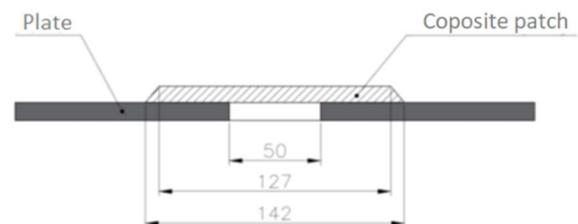
Fig. 3. The diagram of the repair node

The properties of the carbon composite were defined on the basis of 160 g/m<sup>2</sup> carbon fabric by HACOTECH and L285/H285 (MGS) by Havel Composites. The composite patch had the shape of a clipped cone with a back diameter of 142 mm and a top layer diameter of 127 mm (Fig. 3). Due to the use of a conical shape, the occurrence of stress concentration in the joint of the adhesive joint at the edges of the edge overlap was limited. Between the patch and the panel to be repaired, an adhesive layer was modeled with a thickness of 0.1 mm, diameter of 142 mm and the properties of Epidian 57/Z1 adhesive [22].

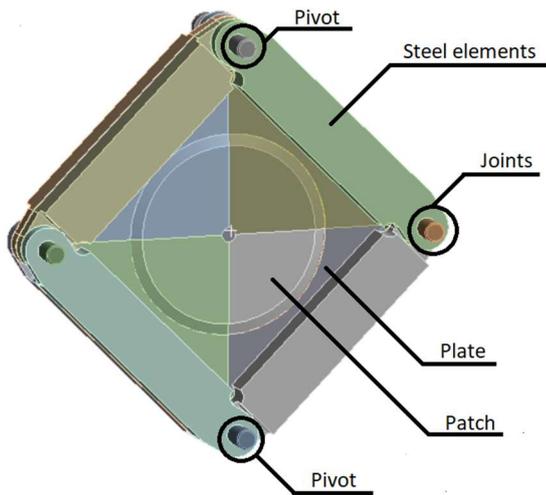
Fig. 4. Geometric model of the repaired plate with a frame

As part of defining the boundary conditions in the load area, a model of the mounting frame was made, which consists of eight steel flat elements connected with each other articulated with four pivots. The scheme of the frame with the plate being repaired is shown in Fig. 4.

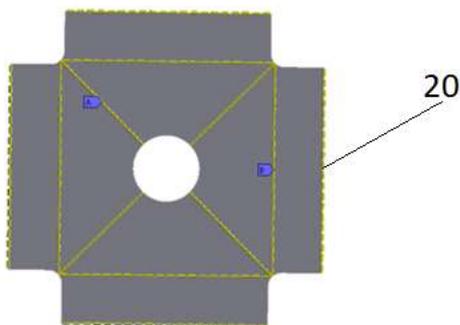
Fig. 5. Scheme of division of the slab model into 8 geometric elements

Using the symmetrical layout of the plate, a regular shape of the plate mesh was defined. For this purpose, the board model was divided into 8 elements (Fig. 5). This type of operation was aimed at obtaining a mesh with a regular shape - Fig. 6.

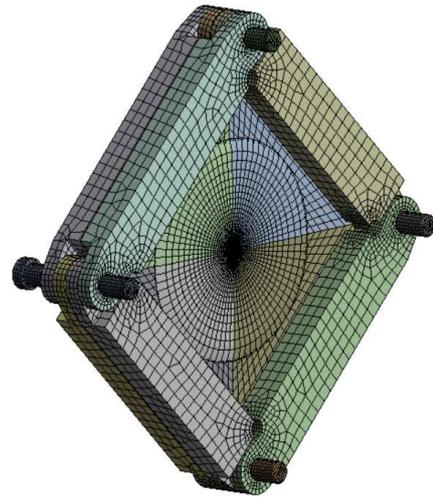
Fig. 6. The view of the model with the division into finite elements, the so-called mesh

The Edge Sizing option was used to define the mesh, assigning 20 elements to individual edges, and the MultiZone option, assuming the type of Hexa element. According to the adopted scheme, a similar division of the composite patch, the adhesive layer and the insert was made. Additionally, the frame elements have been assigned an optimization module of the Hex Dominant type. As a result of discretization, the frame model had 53362 finite elements and 62506 mesh nodes, while the repaired plate had 2400 elements and 5000 nodes.

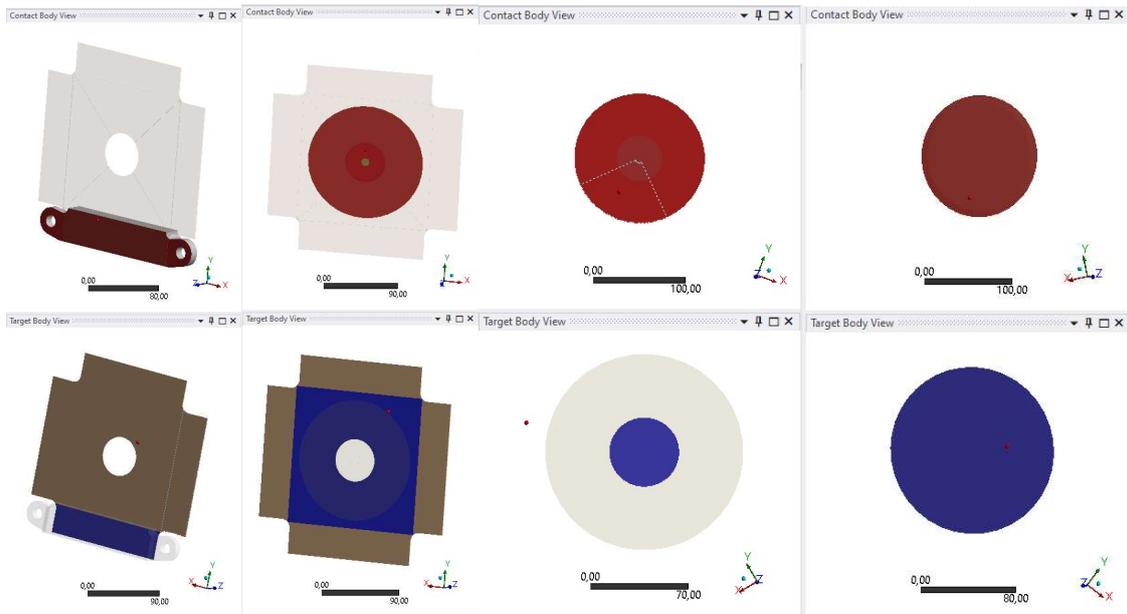
Fig. 7. Bonded contacts between the individual elements (red and purple indicate the contact area), from the left, the frame with the plate, the adhesive layer with the plate, the adhesive layer with the insert and the adhesive layer with the patch

In order to recreate the conditions of assembly the plate to the frame, bonded contacts have been defined between the frame and the plate. The same type of contact is defined between the composite patch and the adhesive layer and between the adhesive layer and the plate and between the insert and the adhesive layer. Figure 7 shows the individual elements for which the type of bonded contact has been defined.

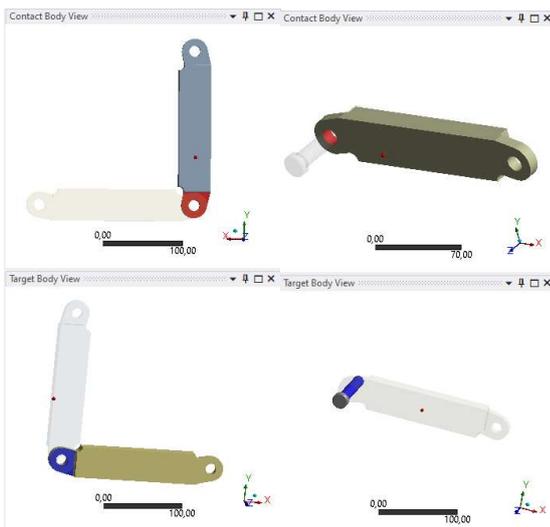
Fig. 8. View of elements between which a No Separation type connection has been defined

The articulated joints were modeled between the frame elements and the pivots using a No Separation contact (slip without friction, Fig. 8).

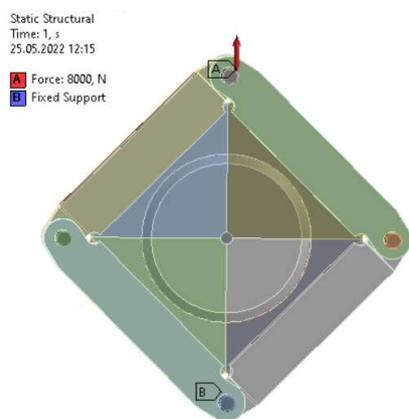
Fig. 9. The diagram of the boundary conditions of the FEM model

In the load area, a force of 8 kN was defined located in the pivot No. 1 directed along the z axis, while the pivot No. 4 was fixed using the Fixed Support function (Fig. 9).

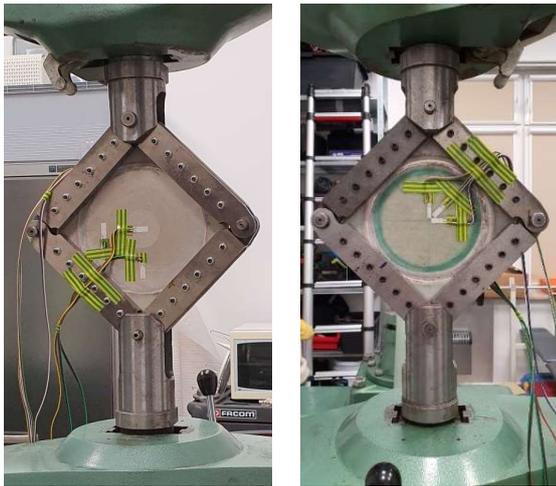
Fig. 10. Fixing the sample in the testing machine

After the specimen was prepared, mounting holes were drilled in it and the specimen with the frame was placed in the traverses of the testing machine. The specimen and the method of its mounting in the machine are shown in fig. 10.

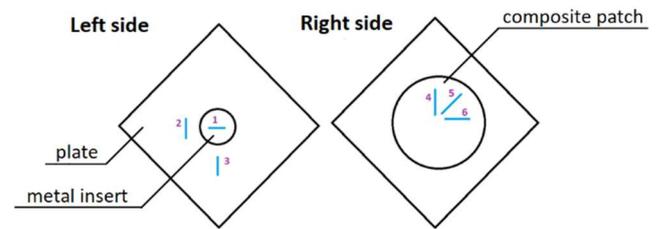
Fig. 11. Distribution and numbering of strain gauges mounted on the specimen

Strain gauges were jointed to the elements of the repair node in accordance with the diagram shown in Fig. 11.

The strain gauge No. 1 is jointed to the metal insert - in the direction perpendicular to the load generated by the testing machine. Strain gauges 2 and 3 were jointed in the direction of load deformation of the testing machine. The strain gauges 4, 5, 6 had the form of a rosette bonded to the composite patch. A CL 460 (Zakład Elektroniki Pomiarowej Wielkości Nielektrycznych, Poland) bridge was used to measure the deformation.

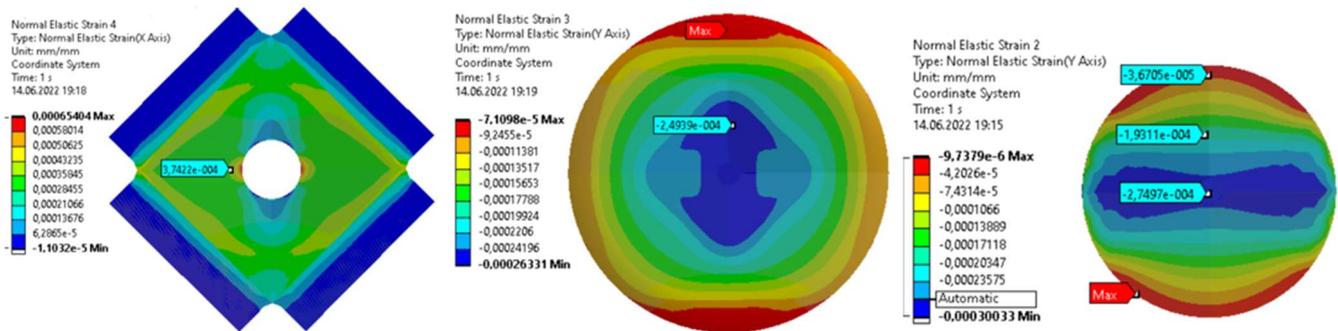
Fig. 12. Deformation values for the plate, glass fiber patch and reinforcement insert

The results of the recorded strain from the experimental tests were compared with the results of the numerical simulation (Fig. 12 and Table 2).

The largest differences in strain between the results of the experimental tests and the results of calculations occur on the composite patch, which may be related to the take simplifications in defining the composite material. In the case of strain gauges

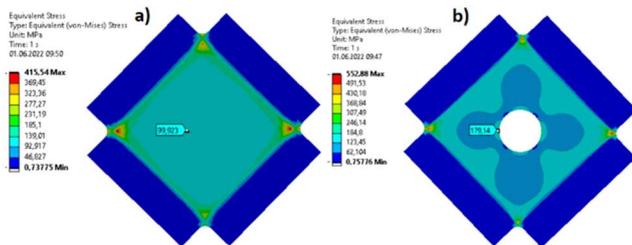
Fig. 13. Reduced stresses in the plate for undamaged (a) and damaged (b)

Stress concentration in an undamaged plate occurs near the corners of the plate. Which in the conditions of a semi-monocoque structure may cause additional stress on the mechanical joints. In the central zone of the plate, where the stress wave formation process takes place, the stress values are below the yield point. Figure 14 presents the results of the stress distribution in the plate repaired with composite patch in two variants (option I - glass composite GFRP, option II - carbon composite CFRP).

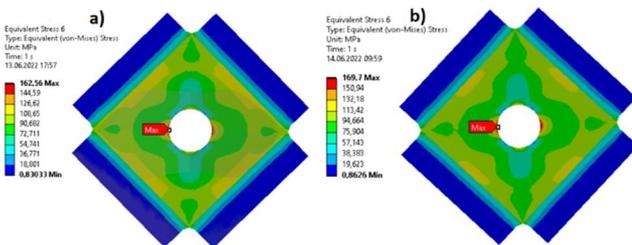
Fig. 14. Reduced stresses in the plate with the GFRP (a) and CFRP (b) patch

Using both GFRP and CFRP, the effort conditions of the undamaged plate were recreated. The greatest changes were observed in the area of the insert mounting hole. The comparison of normal stresses perpendicular to the adhesive surface and the maximum main stresses in the adhesive layer for two patch variants is shown in Fig. 15 and Fig. 16.

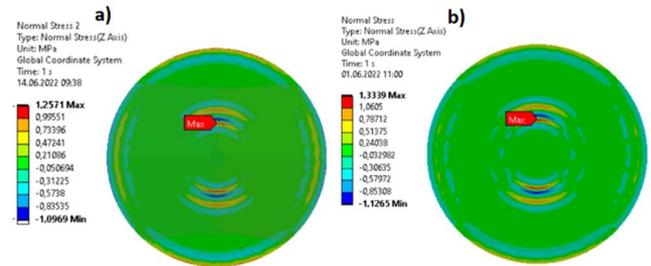
Fig. 15. Normal stresses to the adhesive surface for two patch variants: GFRP (a), CFRP (b)

The values of stresses in the adhesive joint area are lower than the values of breaking stresses defined for Epidian 57/Z2. Table 3 presents the displacement values of the frame model with the specimen for the considered repair values. The smallest values occurred for the CFRP composite patch.

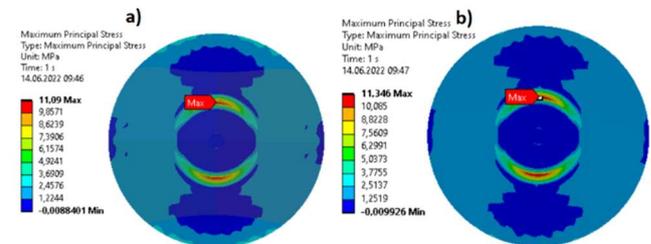
Fig. 16. Maximum main stresses in the adhesive layer for two patch variants: GFRP (a), CFRP (b)
